MINISTRY OF TRANSPORT

REPORT ON THE DERAILMENT

11th February 1961

RUGBY (Central) and LUTTERWORTH  
STATIONS

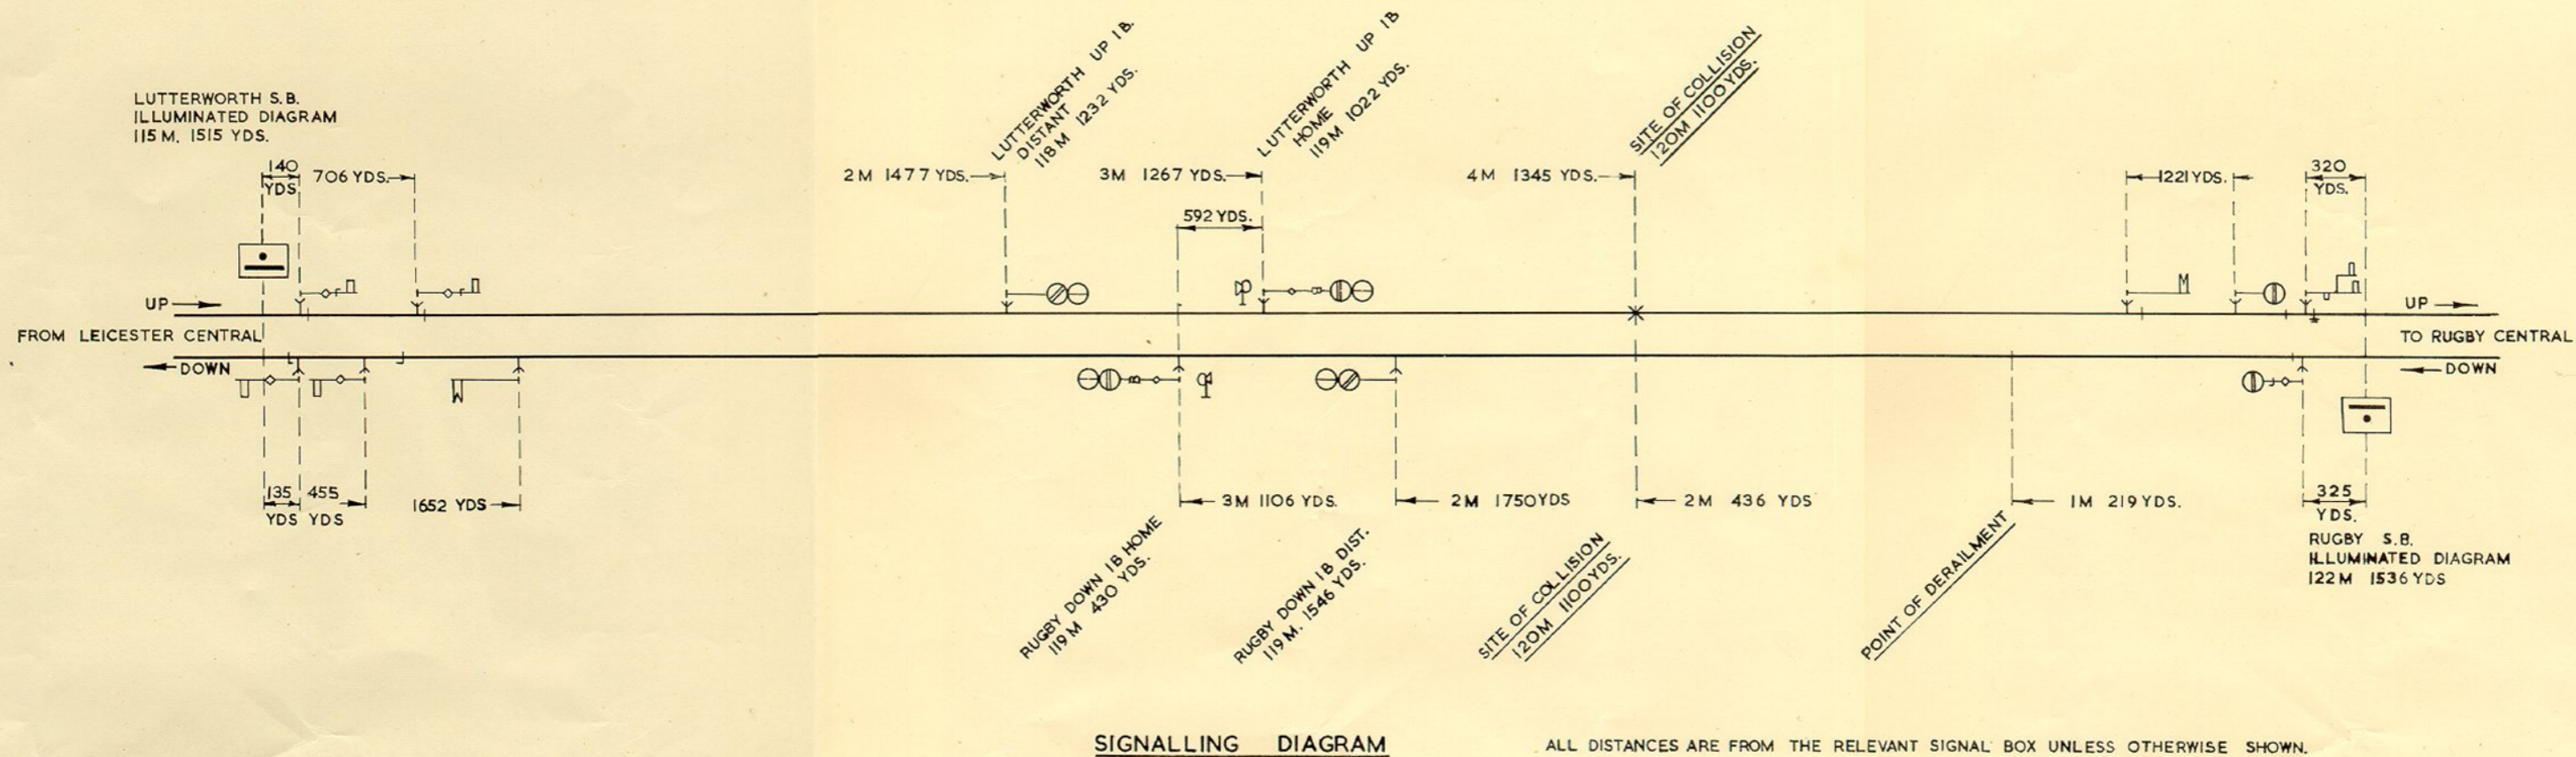
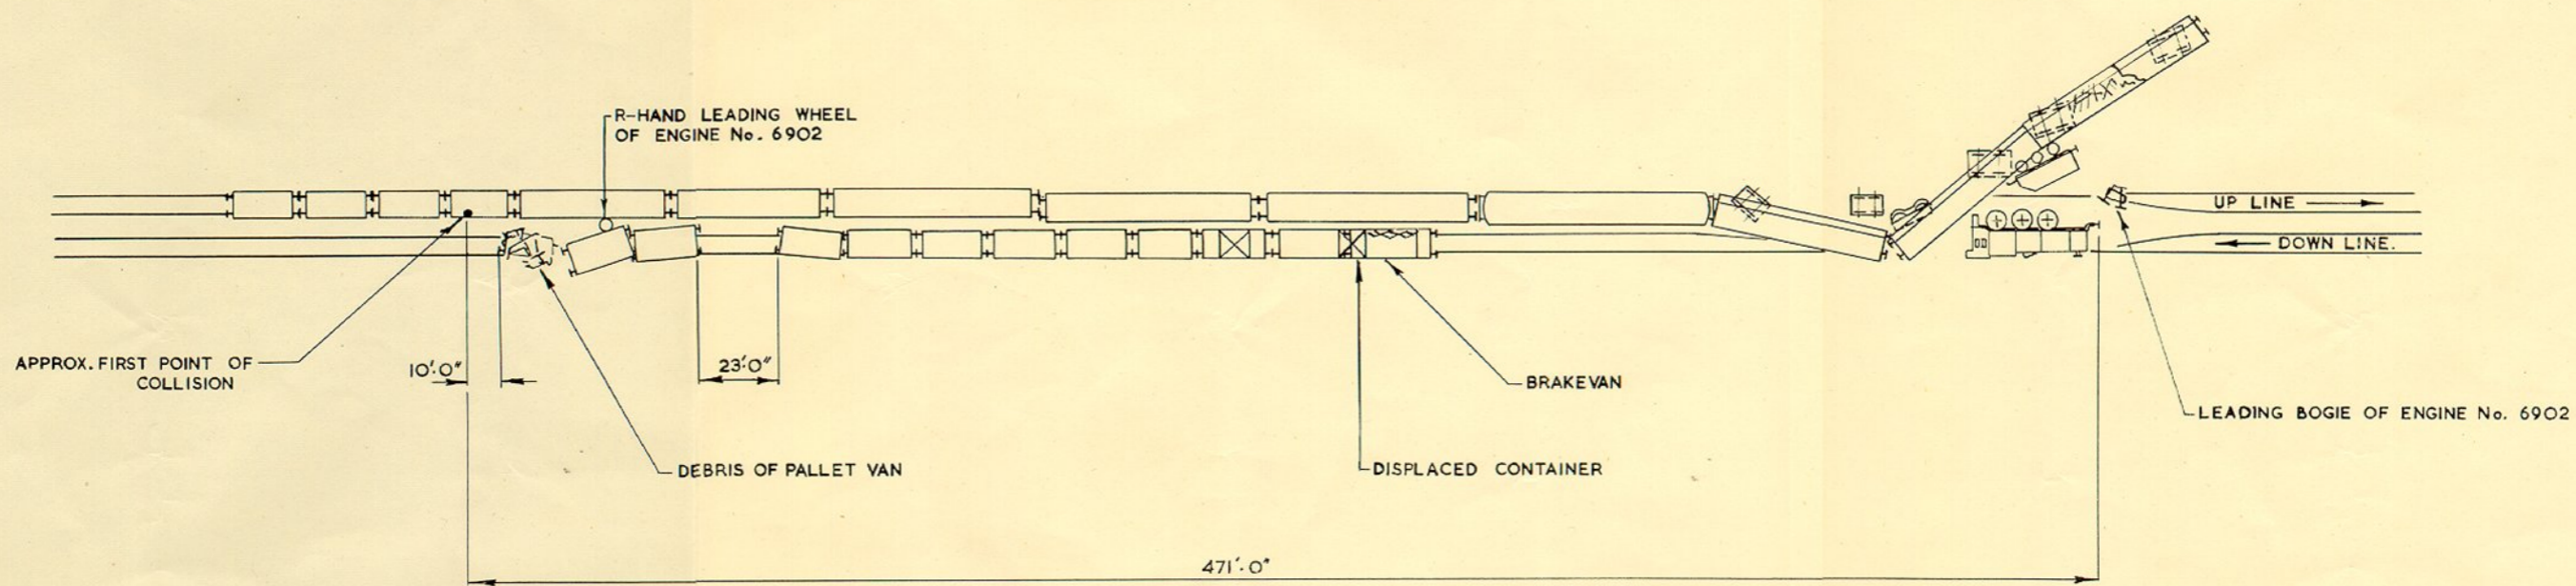
# COLLISION AND DERAILMENT BETWEEN RUGBY AND LUTTERWORTH

until the levers in the boxes concerned have been replaced in the frame and thereafter pulled. Each signal box is equipped above its 40 lever frame with an illuminated diagram which shows the state of the track circuits, occupied or clear, and the aspects of the I.B. signals. Full block controls, including the Welwyn control, are provided; the "Block Release" control locks the lever for the I.B. home signal normal in the frame until the signalman has received line clear from the box ahead; he can, of course, always put the signal to danger at any time by replacing the lever in the frame, though having done so he cannot pull the lever again until he obtains another line clear. Telephones are provided at the I.B. home signals. The relevant distances between boxes, signals, the point of derailment and the site of the collision are shown on the diagram.

11. The front of the third vehicle followed the end of the second one on to the Down line, but the rear end remained over the Up line though the bogie was detached. The fourth vehicle, the first passenger one, remained in alignment though derailed, and the fifth and sixth were also completely derailed, as was the leading bogie of the seventh one. When the train came to rest the fifth vehicle was alongside the brake van of the freight train, and the ninth vehicle (the first of the 4-wheelers) was alongside the leading pallet van which had caused the collision. The position of the express train vehicles and of those of the freight train involved in the collision are shown on the sketch.
